**DISCONTINUATION OF USE / QUARANTINE:
VST2 VG11 FALL ARREST CARRIAGE FROM NEW TECHNELEC**

Discontinuation of use and quarantine of batches of VST2 VG11 fall arrest carriage from NEW TECHNELEC assembled in May 2024 (reference 10/2021) due to non-compliance of a batch of SKYLOTEC energy absorbers with a proven risk to the end user. Immediately stop using the carriages affected by this recall.

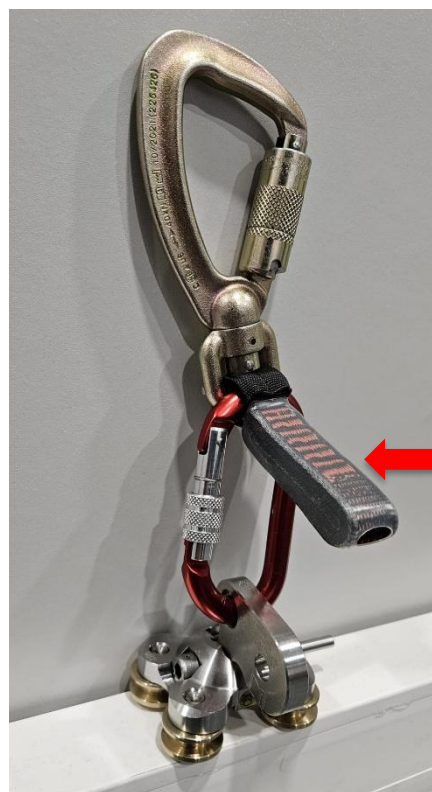
Non-compliant
energy absorber

During tests conducted by the certification body for the purpose of obtaining the C2 module, a non-conformity was identified in the SKYLOTEC energy absorber, a textile component assembled on the VST2 VG11 carriage.

We would like to point out that the design and manufacture of the carriage itself are not in question. Only the SKYLOTEC energy absorber attached to the carriage is non-compliant.

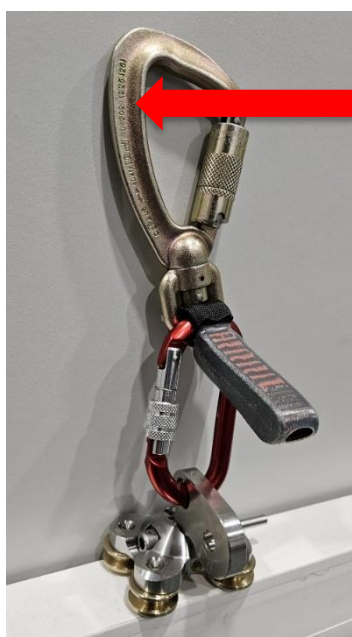
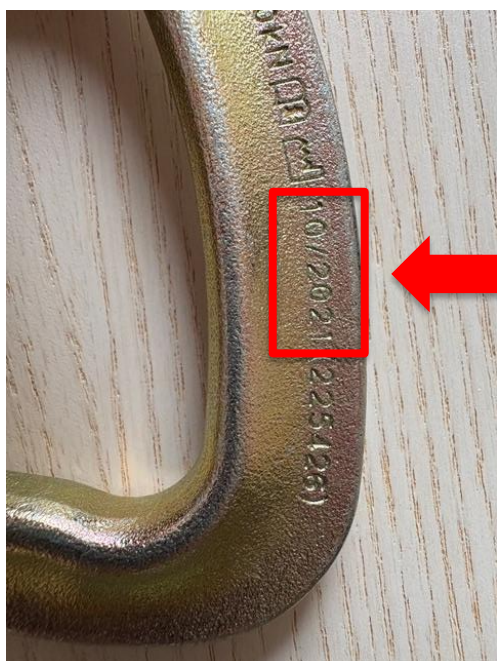
The serial number can be found on the upper SKYLOTEC carabiner to which the defective energy absorber is attached.

The serial number of the defective products is 10/2021.

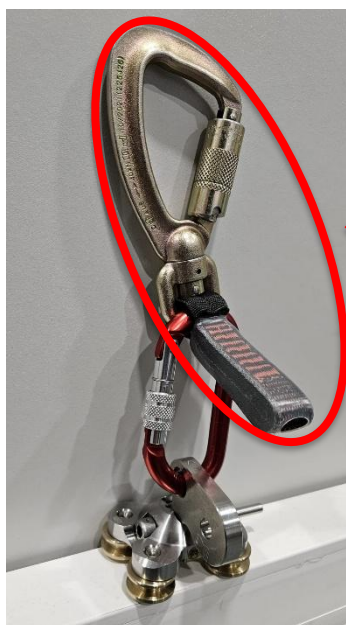
The items circled must be replaced:
SKYLOTEC upper carabiner + the
textile energy absorber sewn onto it.

To correct this non-compliance, the energy absorber and the carabiner to which it is sewn must be replaced as shown in the picture below:
